BDCR Technical Report

May 2011

Bro Dyfi Community Renewables Ltd

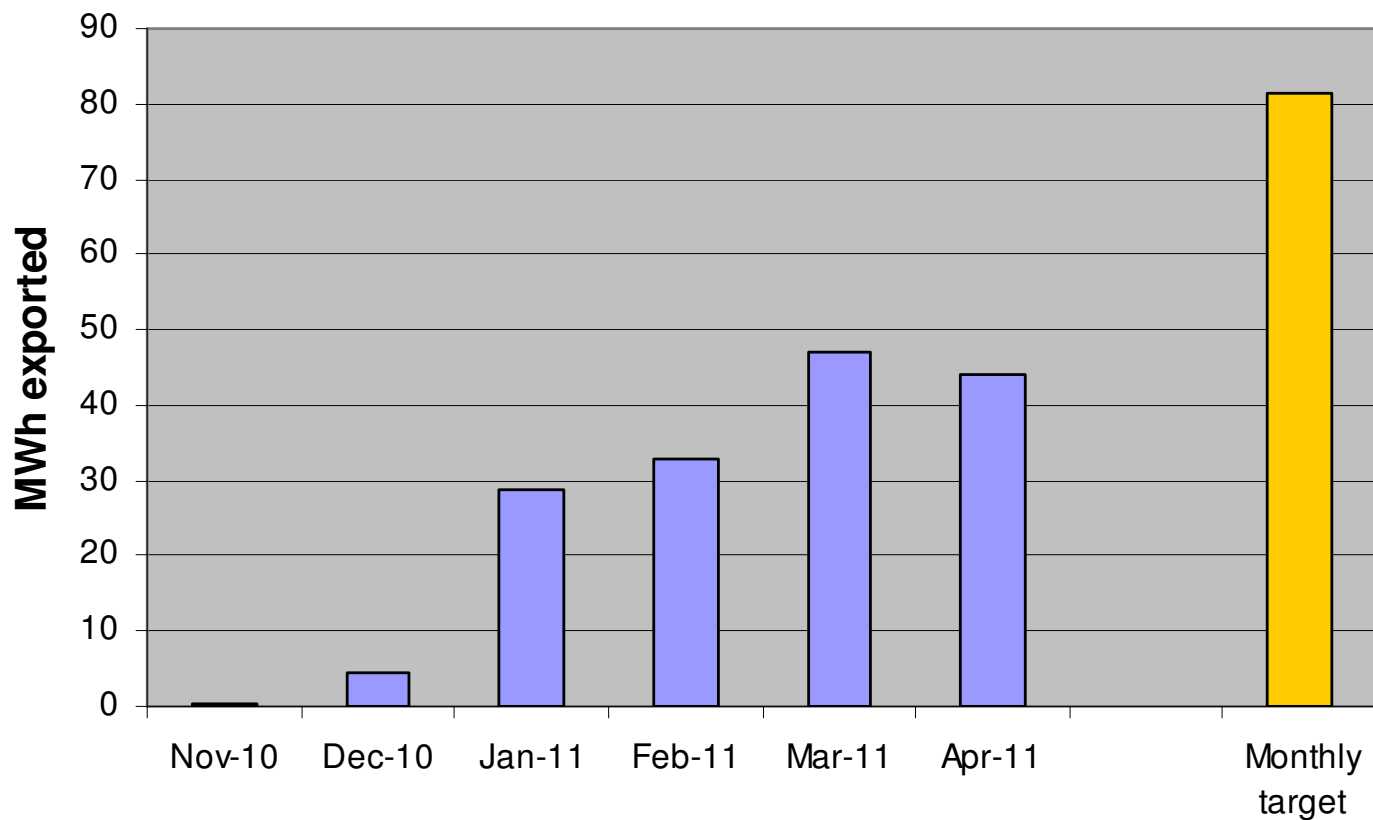
Monthly Production

Local windfarm production down 40% over winter/spring period
