BDCR Technical Report

May 2011

Bro Dyfi Community Renewables Ltd

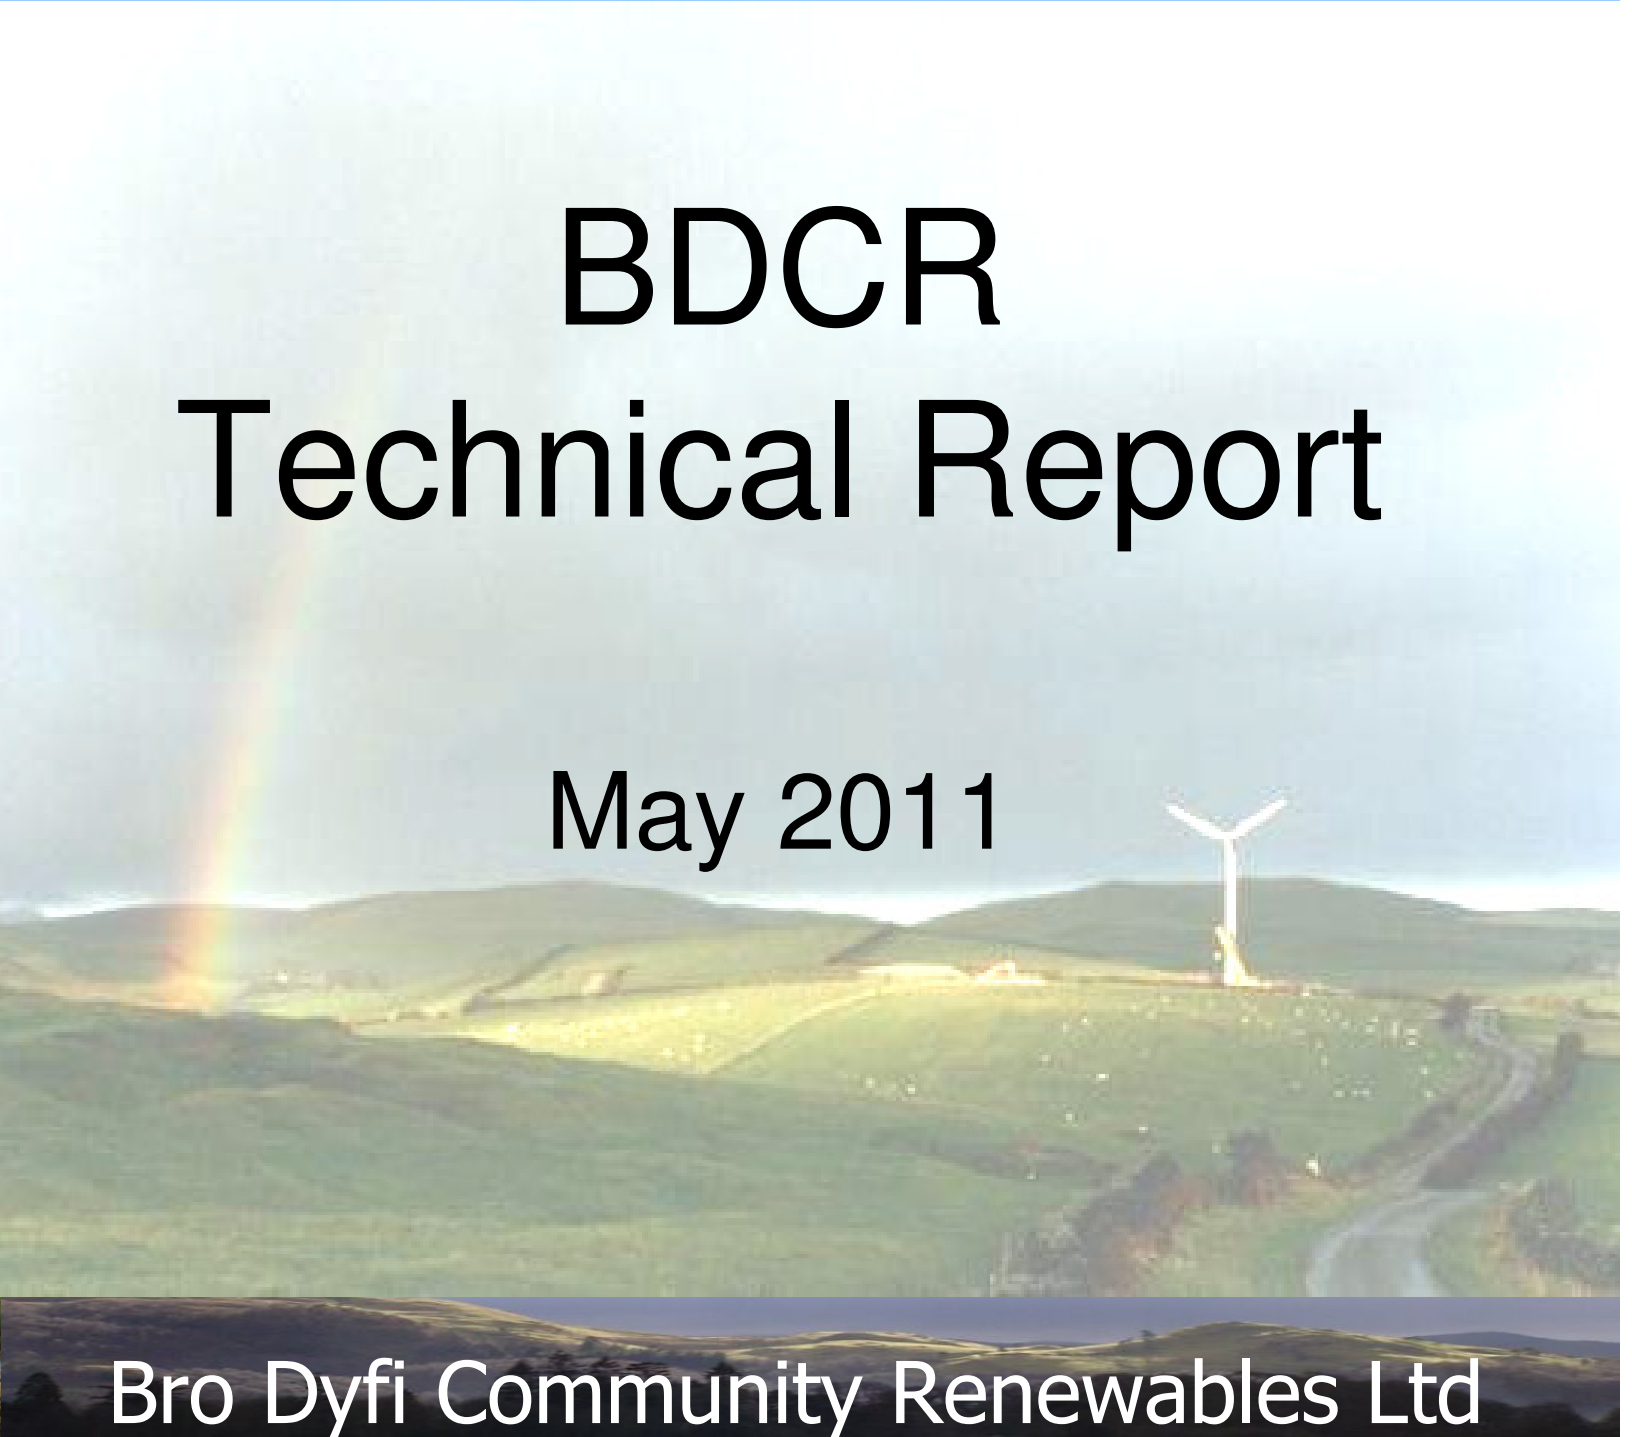
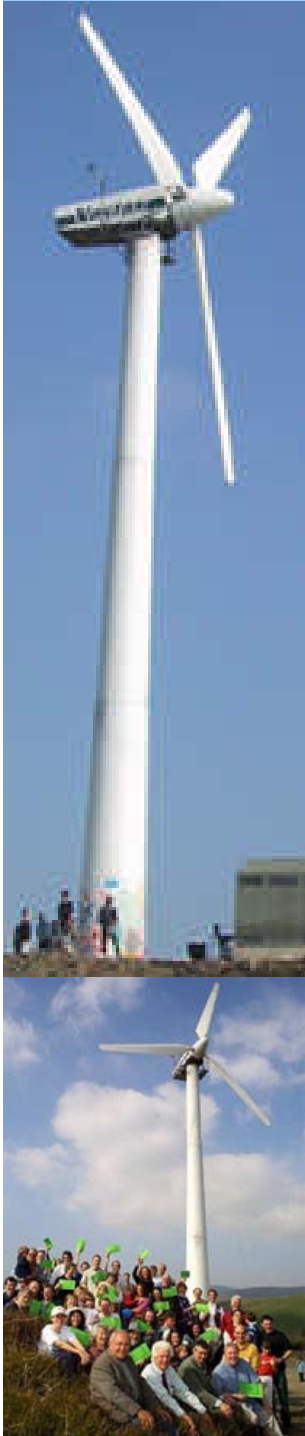
Where we were Jan 2010

- New 11kV cabin installed
- New 11kV switch delivered and wired up

However...

- SP unhappy about damp patch (Aug)

- Extra weather proofing installed
- Ongoing observation of cabin weather-tightness

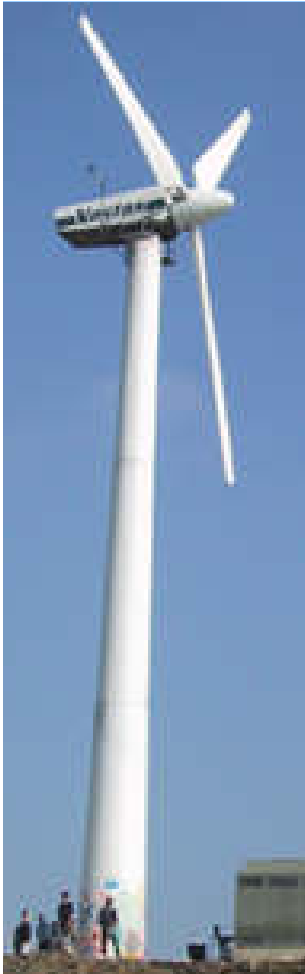
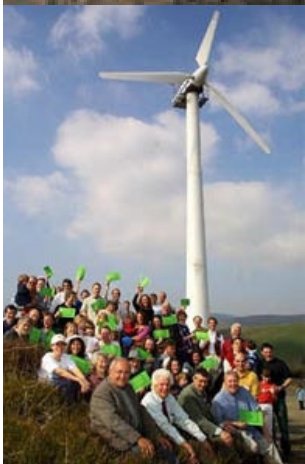
Vestas progress

- Recurrent control faults
- Replaced boards, undertook tests and modifications
- Major cable fault appeared
- Location measured
- Awaiting excavation and repair

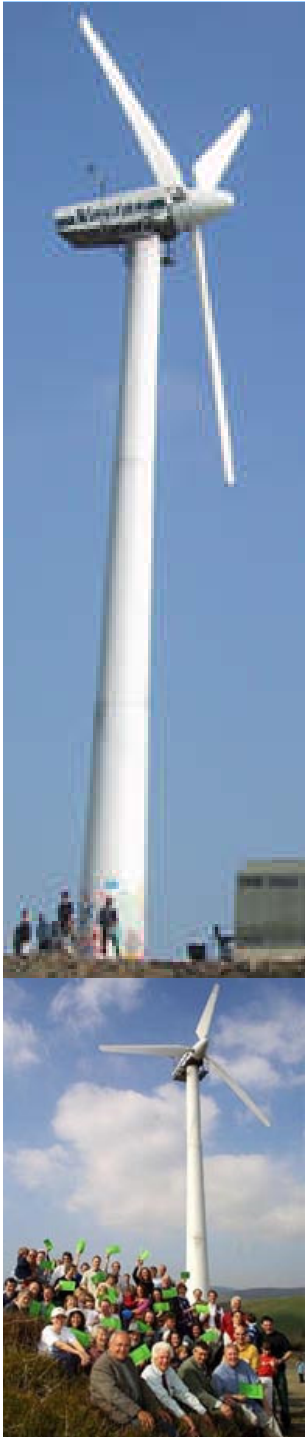
Nordtank progress 2010

- April: Grid connection energised
- Sep: Lightning damaged blade tip replaced
- Oct: Turbine recommissioned
- Nov: G59 test witnessed and meter installed
- Dec: Generation
